FORMER TRW MICROWAVE SITE

Current Site Status and Path Forward

July 9, 2020

AECOM

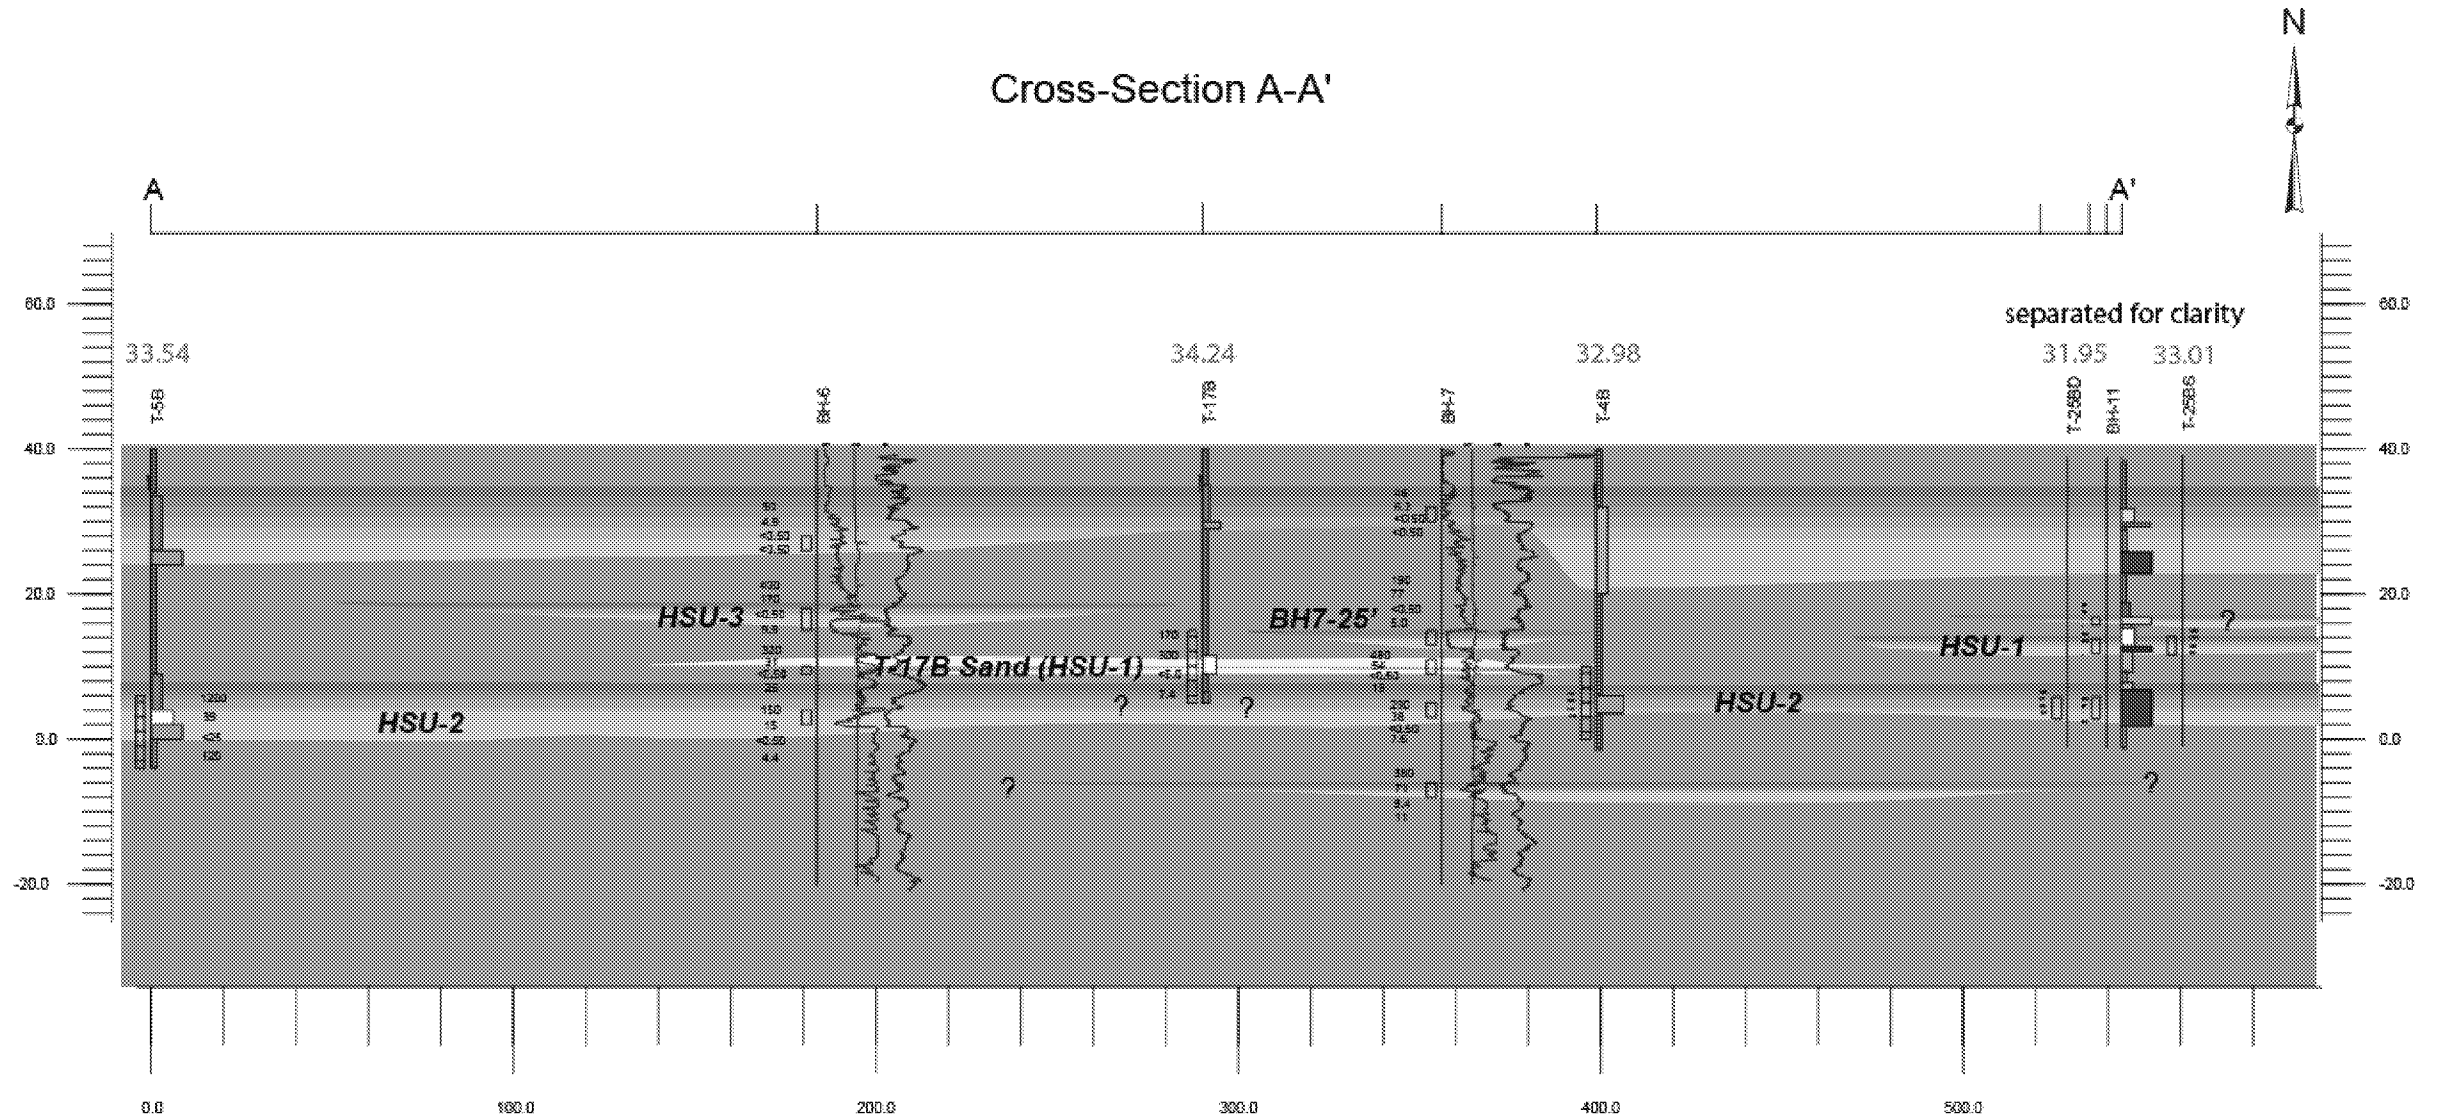
Cross-Section A-A'

Cross Section A-A'

- Continuous HSU-2 channel from offsite (Philips) to downgradient onsite well
